CORE CREEK DAM
BUCKS COUNTY, PENNSYLVANIA
NATIONAL I.D. NO. PA 00802

PHASE I INSPECTION REPORT
NATIONAL DAM INSPECTION PROGRAM

National Dam Inspection Program.
Core Creek Dam (PA00802), Delaware
River Basin, Core Creek, Bucks County,
Pennsylvania. Phase I Inspection Report.

WOODWARD-CLYDE CONSULTANTS
5120 Butler Pike
Plymouth Meeting, Pennsylvania 19462

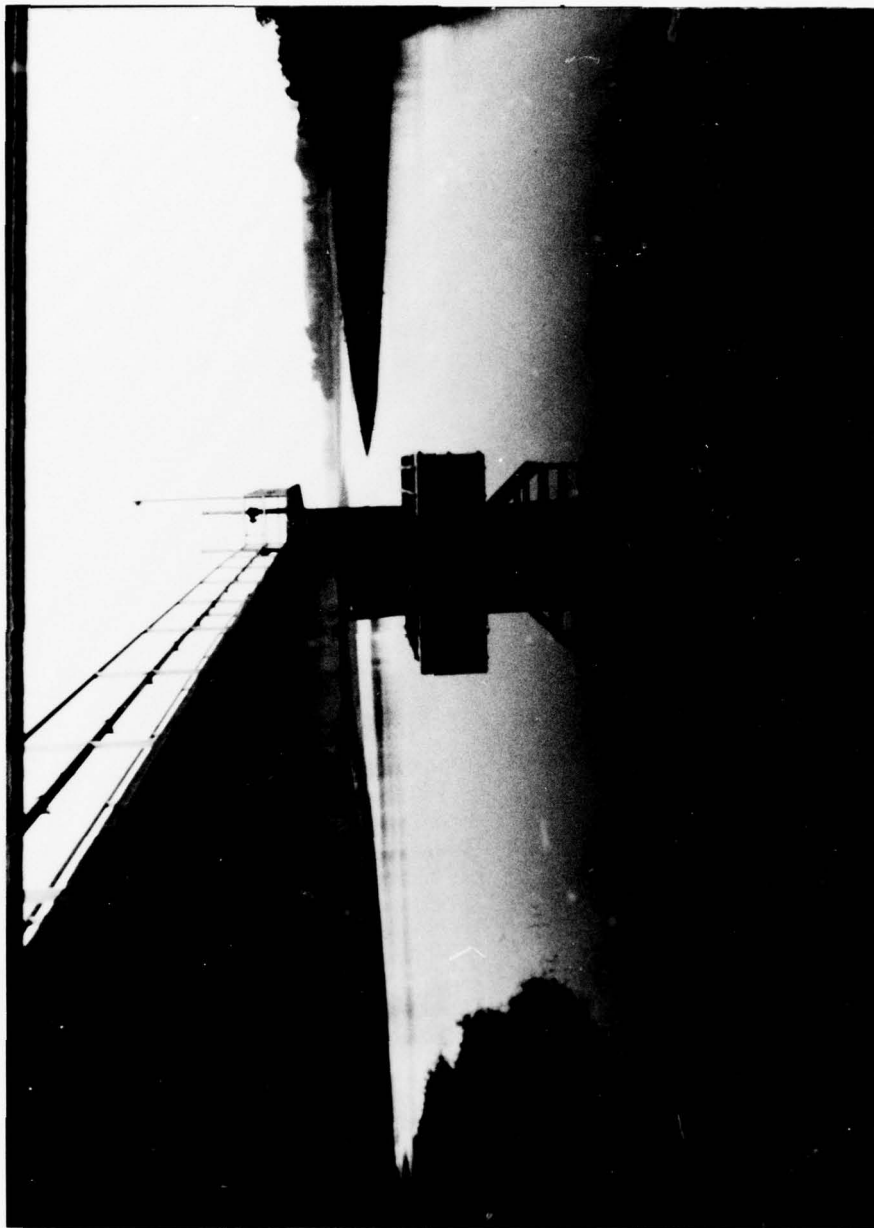
PHOTO NO. 1

VIEW OF INTAKE RISER. TWO LOWER GATED INTAKES CAN
BE SEEN WITH TRASH RACKS.

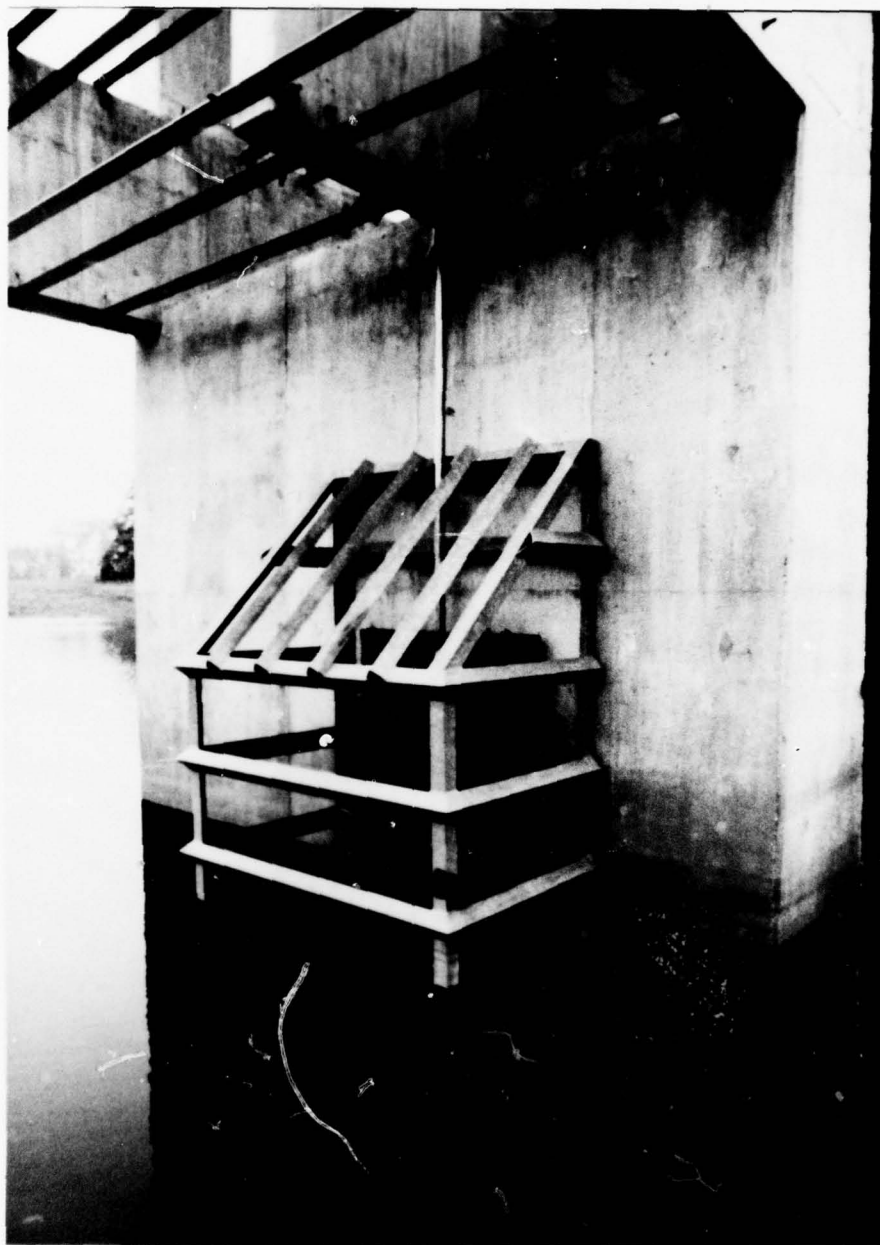
PHOTO NO. 2

c. Appurtenant Structures. At the time of this inspection the reservoir was at the conservation pool elevation of 89. Water was flowing into the lower sluice gate with flow approximately 8 inches above the invert of the gate. Both the lower and the upper sluice gates were inspected and found to be in very good condition. The reservoir drain sluice gate was under water and could not be inspected. The trash racks on the intake tower were inspected and found to be clear of trash. Both the upper and lower sluice gate valves were exercised and found to operate properly, each was painted, cleaned and well greased. The lower sluice gate (drainage gate) was not exercised because debris collection at the base of the gate prevents the gate from closing once it is open. It is understood that the owner's engineer is in the process of correcting this condition. The outlet tunnel could not be inspected beneath the dam because of the flow.

CLOSE-UP VIEW OF LOWER INTAKE SLUICE GATE.

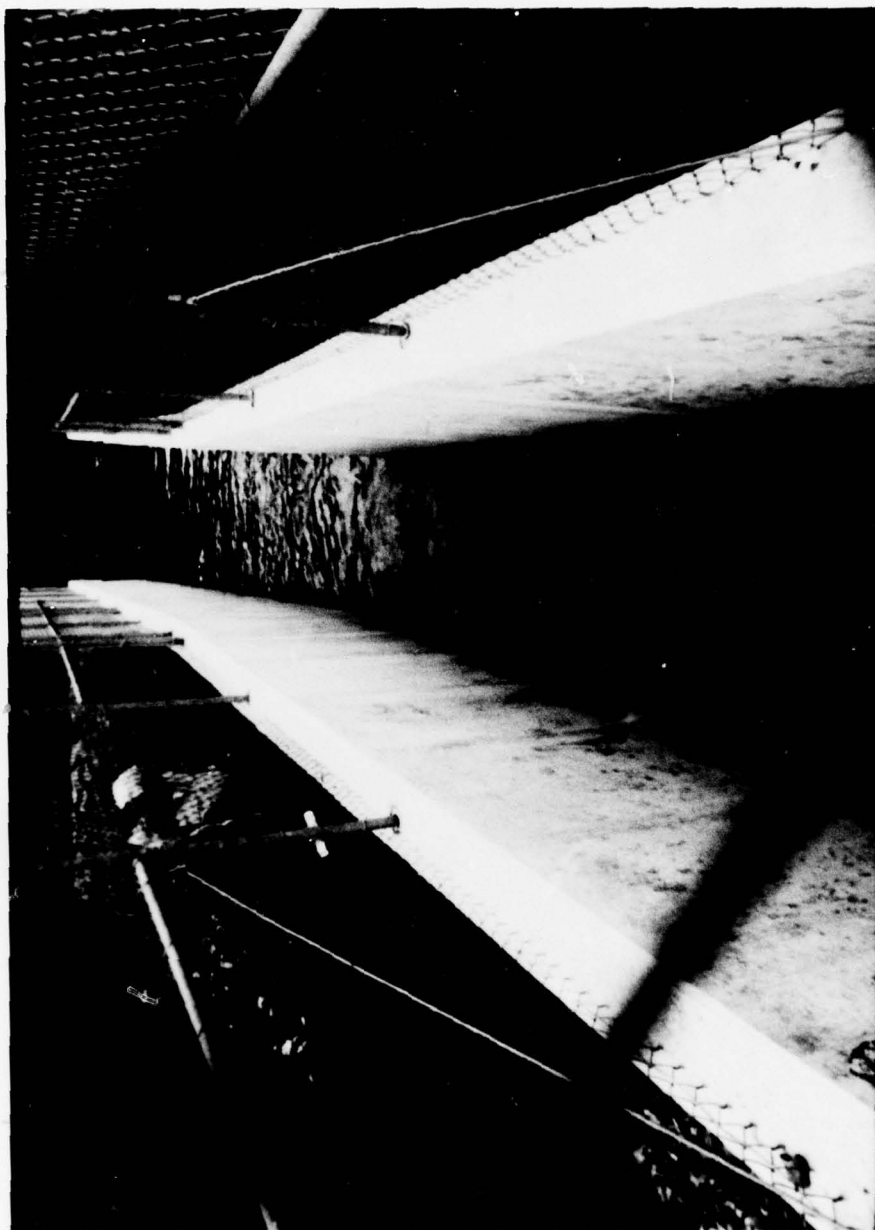
PHOTO NO. 4

The stilling basin was inspected and found to be in excellent condition. There were no signs of cracks, distortions, spalling or deterioration. Six drainage pipes embedded into the wing walls of the stilling basin were also inspected, and two of the flap gates were observed to be broken. This condition, however, did not impede flow. The riprap stilling basin downstream of the wing walls was also inspected. There were no signs of riprap distortion or deterioration.

LOOKING DOWNSTREAM INTO SAF STILLING BASIN.

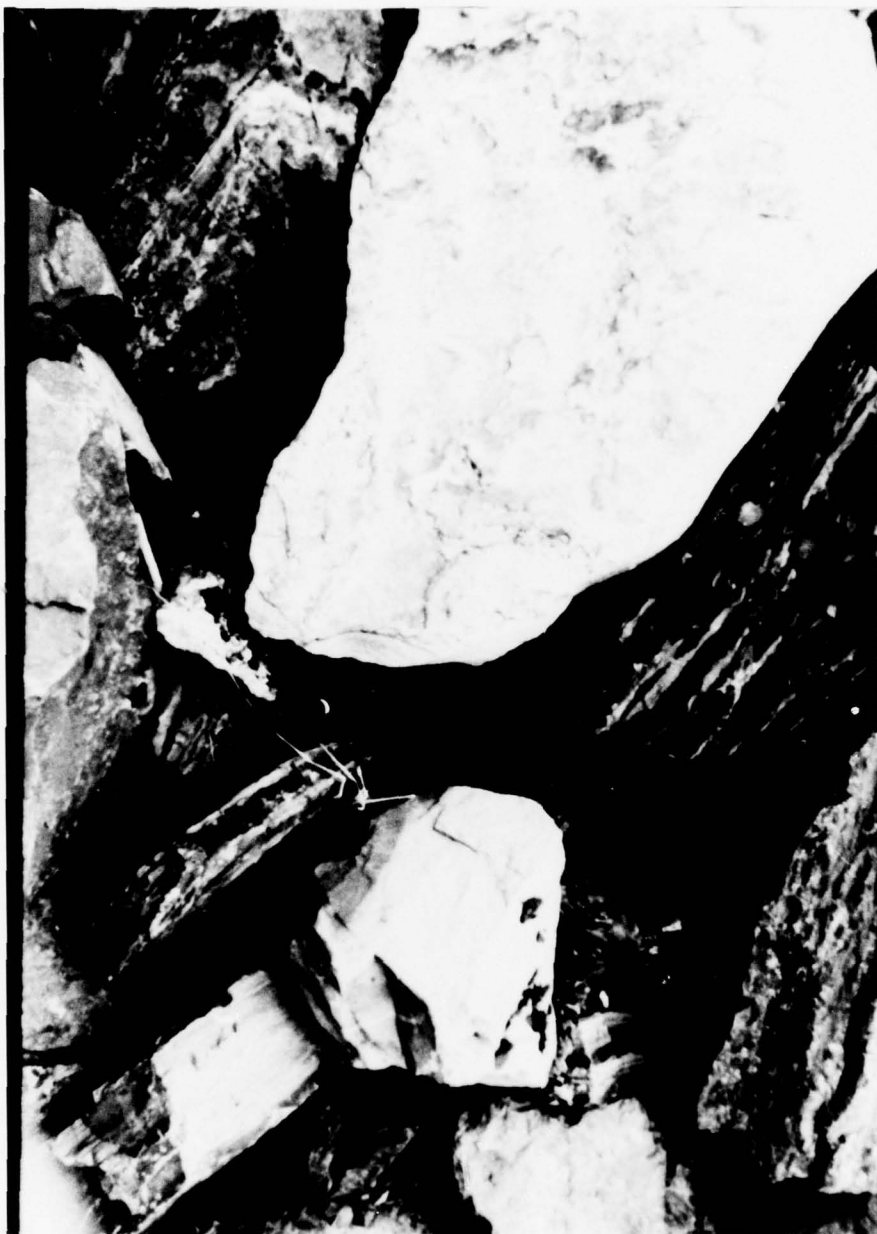
PHOTO NO. 8

The inspection of the riprap slope revealed that some of the riprap appears to be susceptible to slaking with time. The riprap gradation also appears questionable in that it is very large with sizes that range up to 6' x 5' x 3'. The filter bedding beneath the riprap does not appear to be compatible with the larger rock. It was also observed that the density and distribution of the rock matrix is poor with many voids and loose rocks. A review of the SCS drawings shows that the riprap slope was designed to be 2-feet thick. Considering the size of the rock observed during the inspection, it is obvious that the riprap does not meet specifications. The specified rock size could not be located in the contract documents or on the construction drawings.

RIPRAP FAILURES	Some riprap appears as if it would be conducive to slaking. Riprap may fall into reservoir due to erosion of left abutment and embankment junction. Needs protective cover. The riprap gradation appears questionable in that it is very large with sizes up to 6'X5'X3'. Filter bedding does not appear to be compatible with the riprap. The density and compaction of the rock matrix is poor (many voids and loose rock).

VIEW OF RIPRAP ON UPSTREAM SLOPE. NOTE FINE AGGREGATE
FILTER LAYER BETWEEN RIPRAP.

- (1) The Owner should develop an operational procedure to follow in the event of an emergency.
- (2) A formal procedure of observation and warning during periods of high precipitation should be developed and implemented. This should include monitoring of bridges downstream.
- (3) A maintenance inspection checklist should be developed to help insure that all critical items are inspected on a periodic basis.
- (4) The upstream riprap slope should be repaired to minimize future maintenance problems. This can be accomplished by choking the large riprap with 6 to 10 inch stone and reworking the slope.
